석면해체·제거 사업장의 석면비산 측정결과 보고서

1. 측정결과

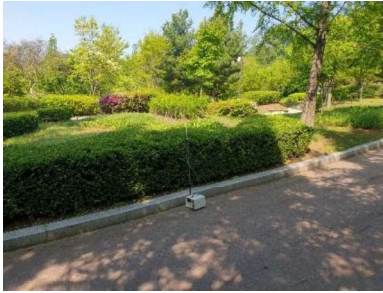
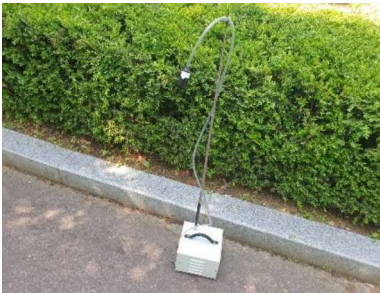
| 구분 | 사진 | | 비 고 |
|---|---|---|---|
| 부지<br>경계선1 | | | |

| | 1 | 부지경계선 | 10.07 | 0.01 | 0.002 | 검출한계미만 |

| 구분 | 사진 | | 비 고 |
|---|---|---|---|
| | 측정시작시간 | 측정종료시간 | |
| | 7:00 | 11:00 | |

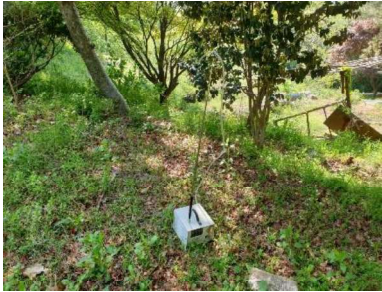
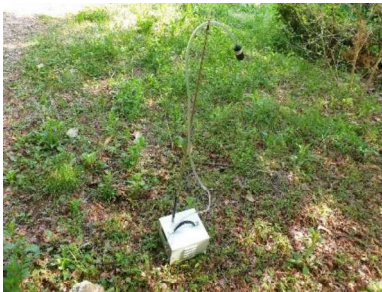
| 구분 | 사진 | | 비 고 |
|---|---|---|---|
| 부지<br>경계선2 | | | |

| | 2 | 부지경계선 | 10.07 | 0.01 | 0.001 | 검출한계미만 |

| 구분 | 사진 | | 비 고 |
|---|---|---|---|
| | 측정시작시간 | 측정종료시간 | |
| | 7:00 | 11:00 | |

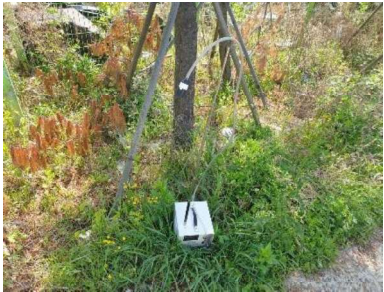
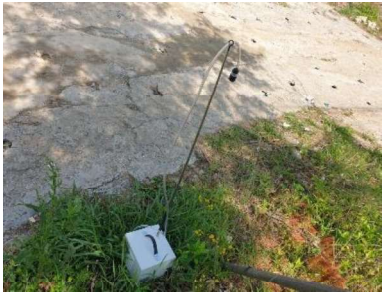
| 구분 | 사진 | | 비 고 |
|---|---|---|---|
| 부지<br>경계선3 | | | |

| | 3 | 부지경계선 | 10.06 | 0.01 | 0.002 | 검출한계미만 |

| 구분 | 사진 | | 비 고 |
|---|---|---|---|
| | 측정시작시간 | 측정종료시간 | |
| | 7:00 | 11:00 | |

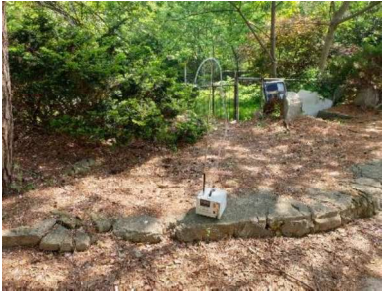
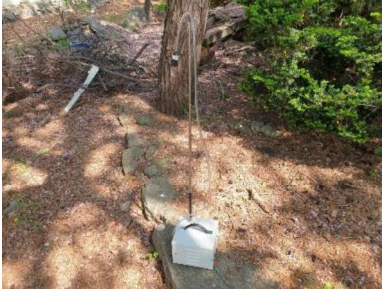
| 구분 | 사진 | | 비 고 |
|---|---|---|---|
| 부지<br>경계선4 | | | |

| | 4 | 부지경계선 | 10.08 | 0.01 | 0.001 | 검출한계미만 |

| 구분 | 사진 | | 비 고 |
|---|---|---|---|
| | 측정시작시간 | 측정종료시간 | |
| | 7:00 | 11:00 | |

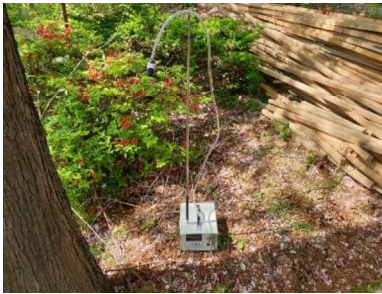
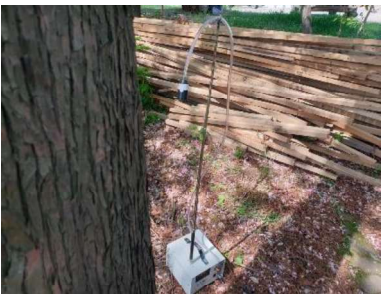
| 구분 | 사진 | | |
|---|---|---|--|
| 작업장<br>주변<br>(실외) | | | |

| | 5 | 작업장주변(실외) | 10.11 | 0.01 | 0.001 | 검출한계미만 |

| 구분 | 사진 | | |
|---|---|---|--|
| | 측정시작시간 | 측정종료시간 | |
| | 7:00 | 9:00 | |

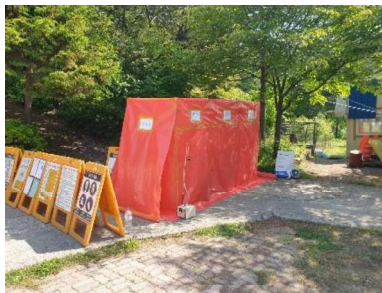
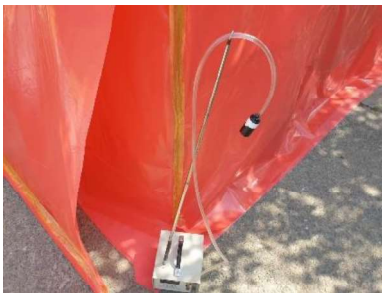
| 구분 | 사진 | | |
|---|---|---|--|
| 위생설비입<br>구 | | | |

| | 6 | 위생설비입구 | 10.09 | 0.01 | 0.002 | 검출한계미만 |

| 구분 | 사진 | | |
|---|---|---|--|
| | 측정시작시간 | 측정종료시간 | |
| | 7:00 | 9:00 | |

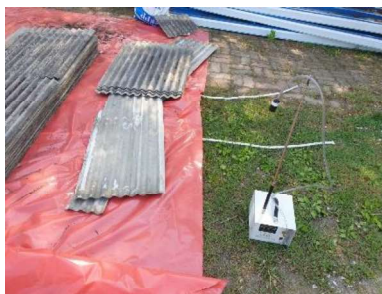
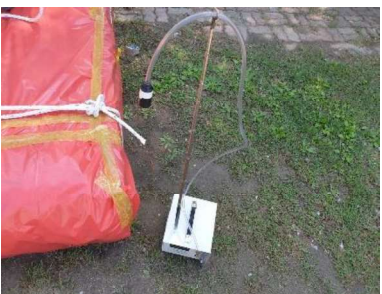
| 구분 | 사진 | | |
|---|---|---|--|
| 폐기물<br>반출지점 | | | |

| | 7 | 폐기물반출지점 | 10.09 | 0.01 | 0.004 | 검출한계미만 |

| 구분 | 사진 | | |
|---|---|---|--|
| | 측정시작시간 | 측정종료시간 | |
| | 8:00 | 10:00 | |
