석면해체·제거 사업장의 석면비산 측정결과 보고서

1. 측정결과

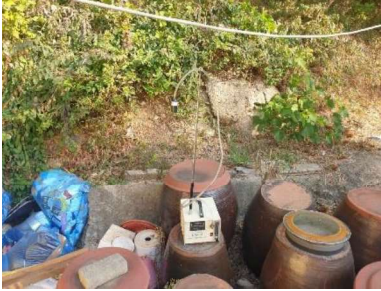
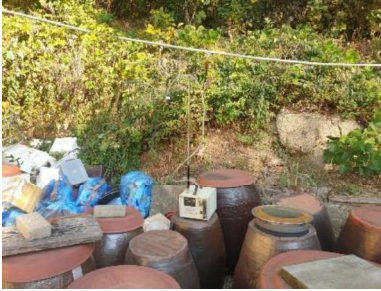
| 구분 | 사진 | | 비 고 |
|---|---|---|---|
| 부지<br>경계선1 | | | |

| | 1 | 부지경계선 | 10.07 | 0.01 | 0.002 | 검출한계미만 |

| 구분 | 사진 | | 비 고 |
|---|---|---|---|
| | 측정시작시간 | 측정종료시간 | |
| | 8:00 | 12:00 | |

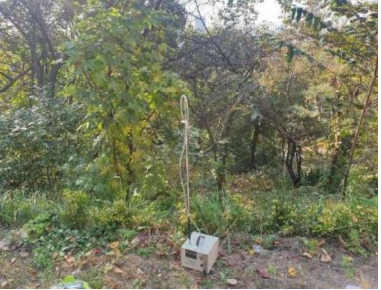
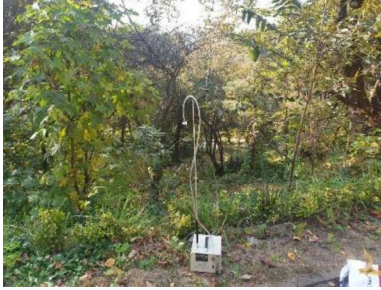
| 구분 | 사진 | | 비 고 |
|---|---|---|---|
| 부지<br>경계선2 | | | |

| | 2 | 부지경계선 | 10.07 | 0.01 | 0.002 | 검출한계미만 |

| 구분 | 사진 | | 비 고 |
|---|---|---|---|
| | 측정시작시간 | 측정종료시간 | |
| | 8:00 | 12:00 | |

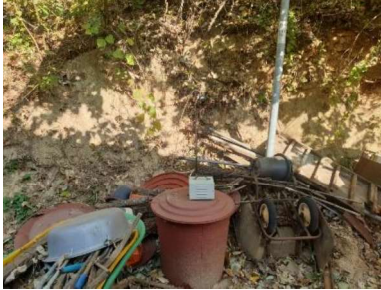
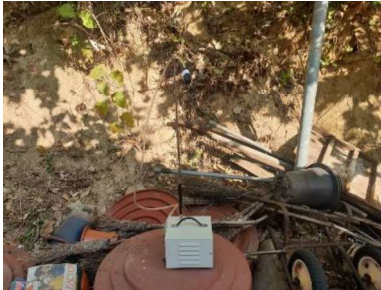
| 구분 | 사진 | | 비 고 |
|---|---|---|---|
| 부지<br>경계선3 | | | |

| | 3 | 부지경계선 | 10.08 | 0.01 | 0.003 | 검출한계미만 |

| 구분 | 사진 | | 비 고 |
|---|---|---|---|
| | 측정시작시간 | 측정종료시간 | |
| | 8:00 | 12:00 | |

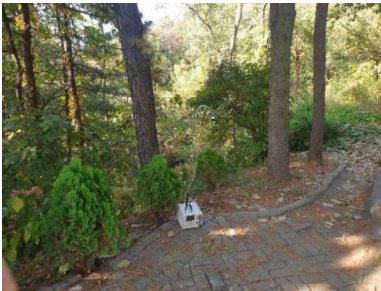
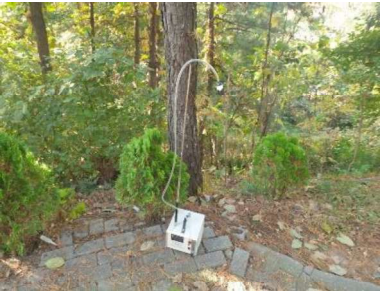
| 구분 | 사진 | | 비 고 |
|---|---|---|---|
| 부지<br>경계선4 | | | |

| | 4 | 부지경계선 | 10.06 | 0.01 | 0.002 | 검출한계미만 |

| 구분 | 사진 | | 비 고 |
|---|---|---|---|
| | 측정시작시간 | 측정종료시간 | |
| | 8:00 | 12:00 | |

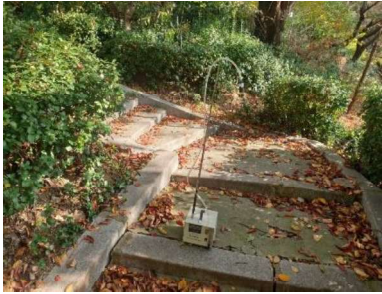
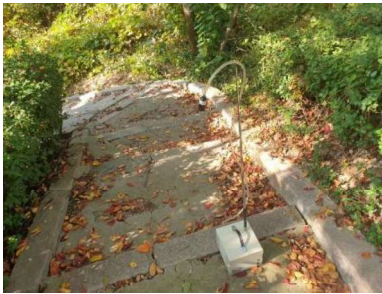
| 구분 | 사진 | | |
|---|---|---|--|
| 작업장<br>주변<br>(실외) | | | |

| | 5 | 작업장주변(실외) | 10.05 | 0.01 | 0.001 | 검출한계미만 |

| 구분 | 사진 | | |
|---|---|---|--|
| | 측정시작시간 | 측정종료시간 | |
| | 8:10 | 10:20 | |

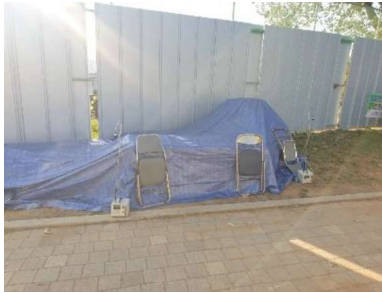
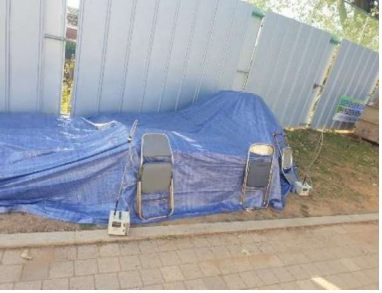
| 구분 | 사진 | | |
|---|---|---|--|
| 폐기물<br>보관지점 | | | |

| | 6 | 폐기물보관지점 | 10.03 | 0.01 | 0.001 | 검출한계미만 |
| | 7 | 폐기물보관지점 | 10.03 | 0.01 | 0.001 | 검출한계미만 |

| 구분 | 사진 | | |
|---|---|---|--|
| | 측정시작시간 | 측정종료시간 | |
| | 8:15 | 10:15 | |

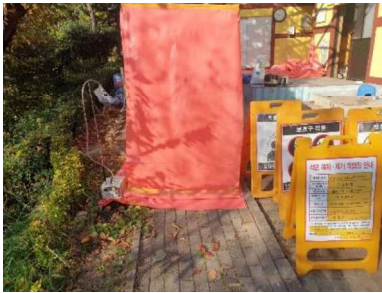
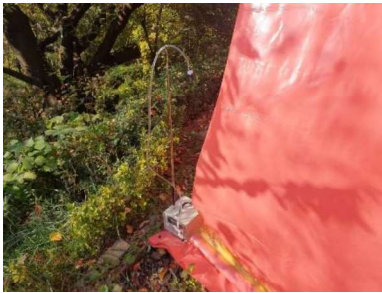
| 구분 | 사진 | | |
|---|---|---|--|
| 위생설비입<br>구 | | | |

| | 8 | 위생설비입구 | 10.08 | 0.01 | 0.003 | 검출한계미만 |

| 구분 | 사진 | | |
|---|---|---|--|
| | 측정시작시간 | 측정종료시간 | |
| | 8:30 | 10:30 | |

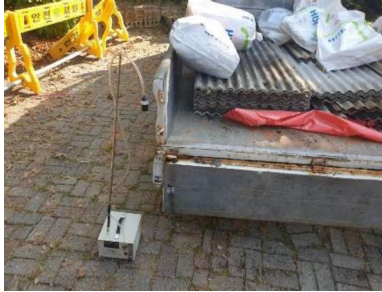
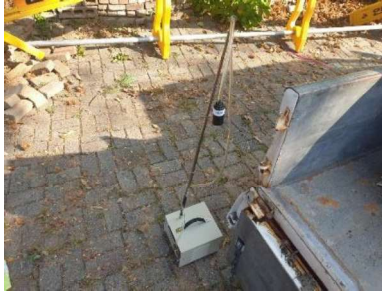
| 구분 | 사진 | | |
|---|---|---|--|
| 폐기물<br>반출지점 | | | |

| | 9 | 폐기물반출지점 | 10.09 | 0.01 | 0.005 | 검출한계미만 |

| 구분 | 사진 | | |
|---|---|---|--|
| | 측정시작시간 | 측정종료시간 | |
| | 8:40 | 10:40 | |
